**Docket No. 217 – Development and Management Plan Inspection**

**Date:** March 2, 2005

**Inspector:** Diana Walden

**Location:** 345kV XLPE Component

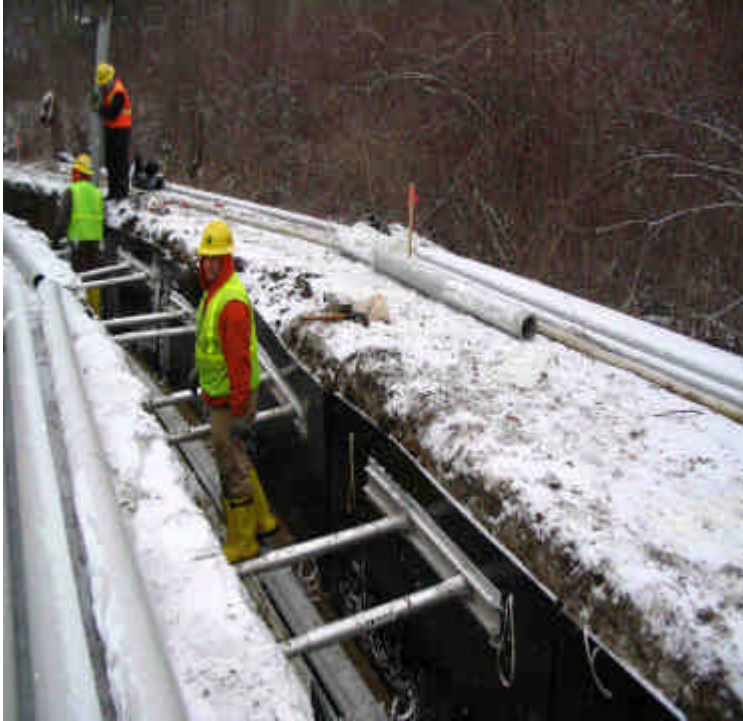
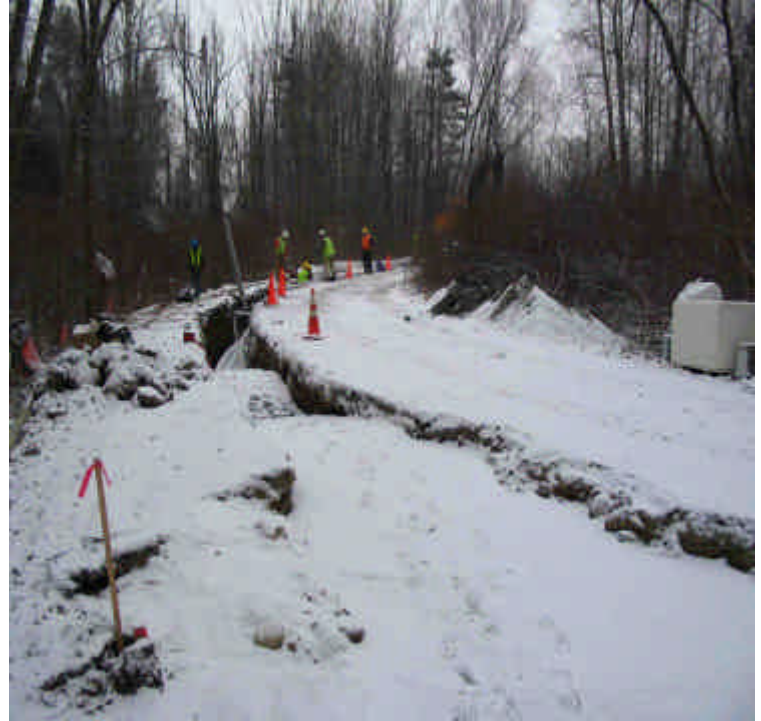
**345kV XLPE (Plumtree Substation): Both photos show the work within the access drive to Plumtree Substation where trenching is underway and the conduit bank is being installed. 3/2/06**

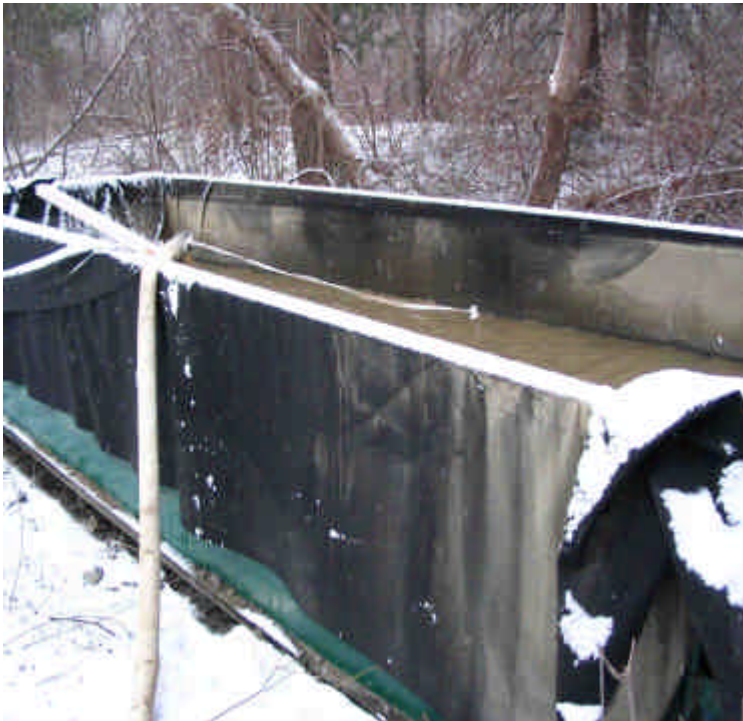
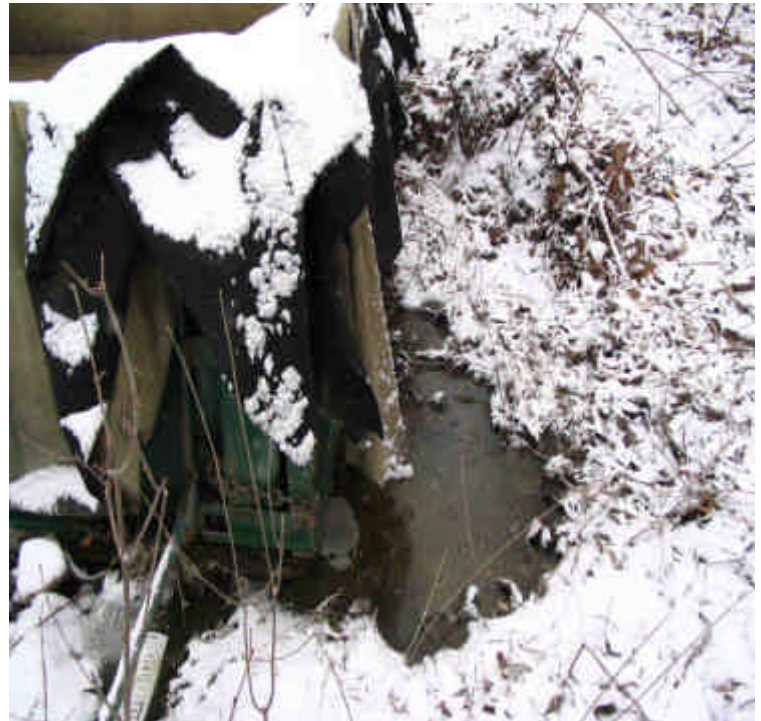
**Photos show the effective set-up used to filter discharge water from dewatering the trench in this area. The box is lined with filter fabric overlain on stone and haybales. Photo on the right shows the water leaving the box well filtered. 3/2/06**

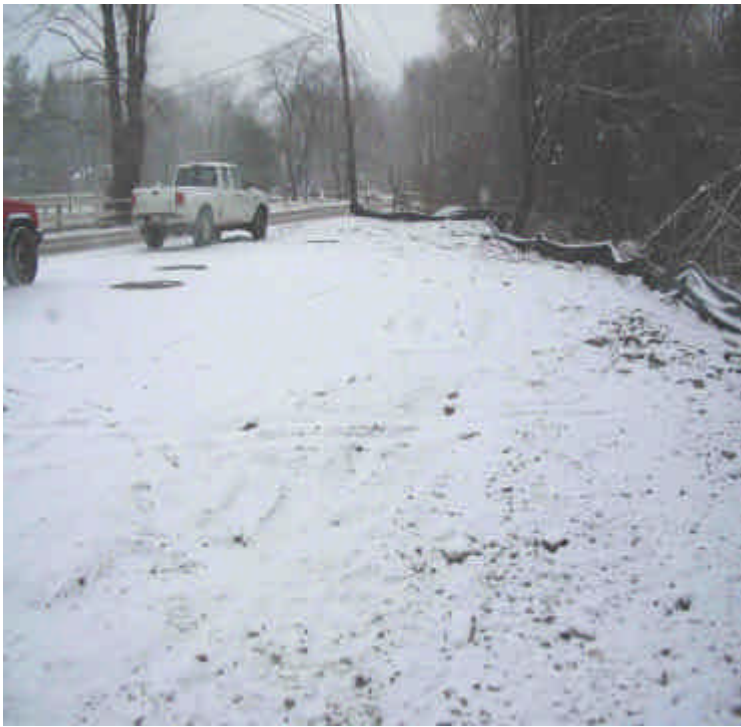
**(Vault 2A-B):** Photo on the left shows the pull-off where the vault was installed. Stone remains in place. Photo on the right shows one of several stone/snow piles that was placed beyond the silt fence when the area was plowed. Piles should be pulled back to the work side of the fence 3/2/06

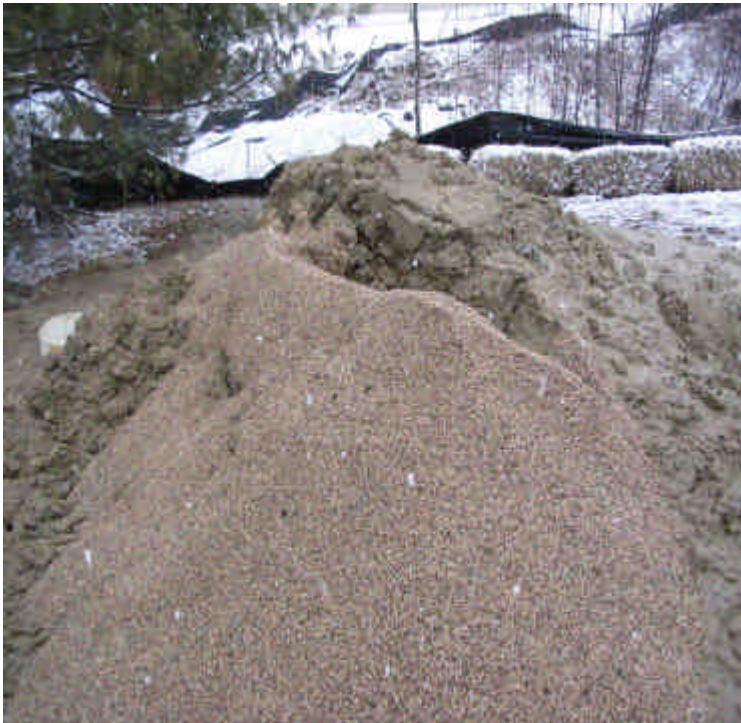
**(Jack&Bore):** Photo on the left shows the sediment pile resulting from installing a well point as well as placing some of the filtering sand. Photo on the right shows the controls installed beyond the pile at the riverbank. This pile should be removed before the next rain event to remove a potential source of sedimentation. 3/2/06

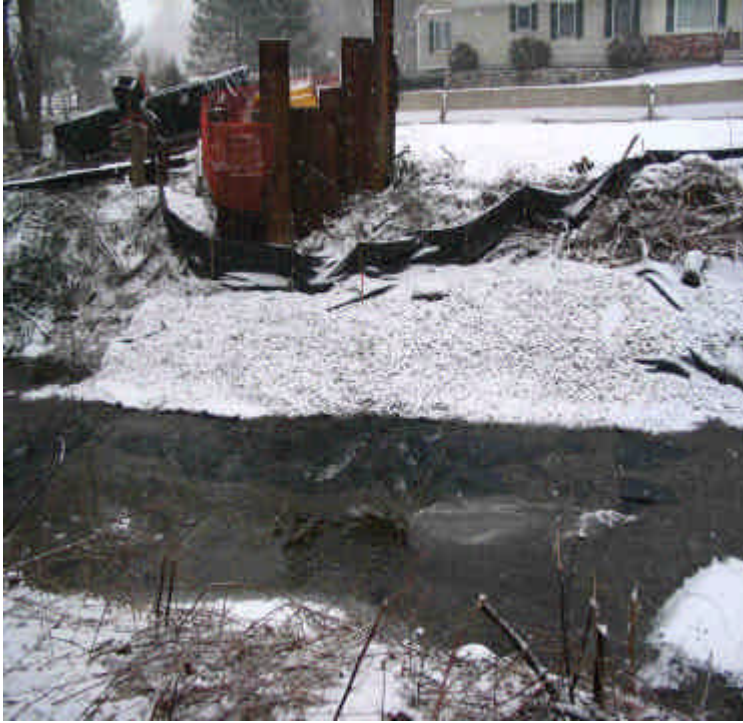
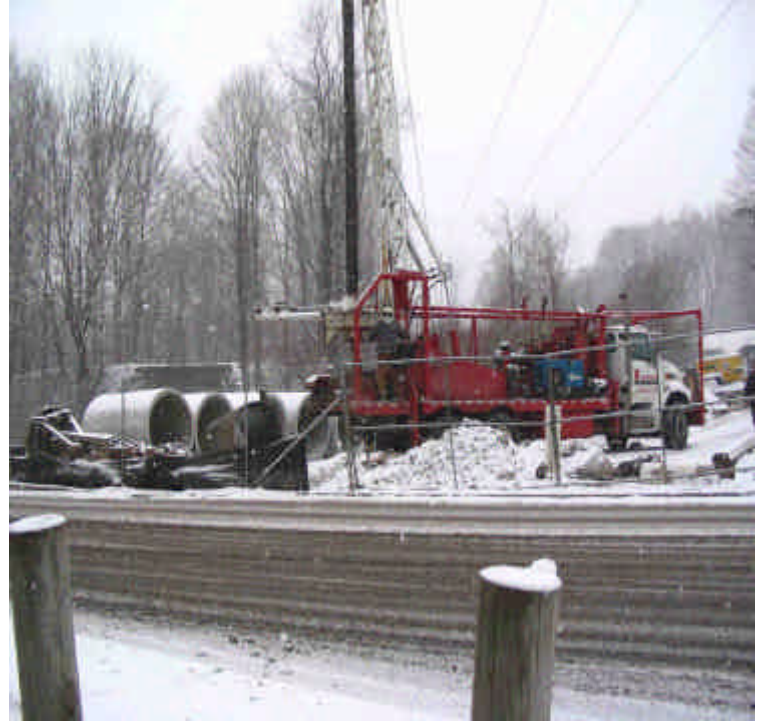
Photo on the left shows the receiving side of the stream which is still well stabilized with the stone and plastic liner. Photo on the right shows a view of the work at the bore pad. 3/2/06

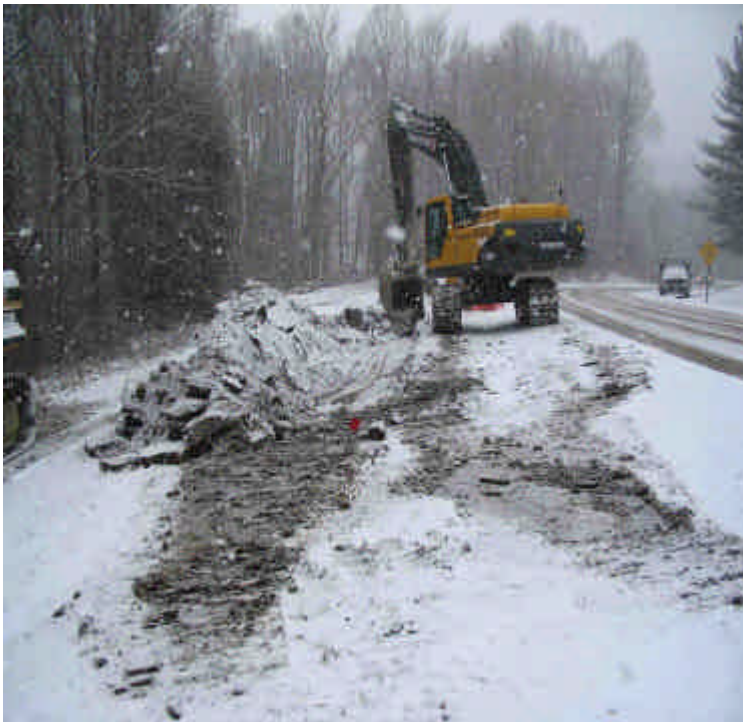
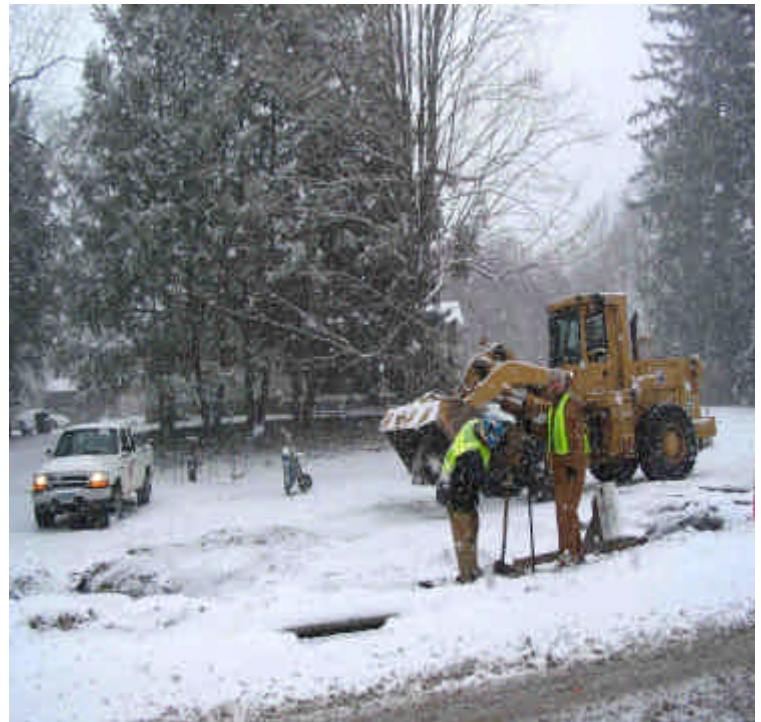
(Vaults): Photo on the left shows vault installation along Whittlesley Drive near Bethel Ed. Park. Photo on the right shows the work to install vault 5A and B near the Rt 302 intersection. Both sites are free of adjacent resource areas. Watch protection of catch basins if necessary. 3/2/06
